Name of Dam: Sherando

Location: Augusta County, State of Virginia

Inventory Number: VA 01520

PHASE I INSPECTION REPORT  
NATIONAL DAM SAFETY PROGRAM

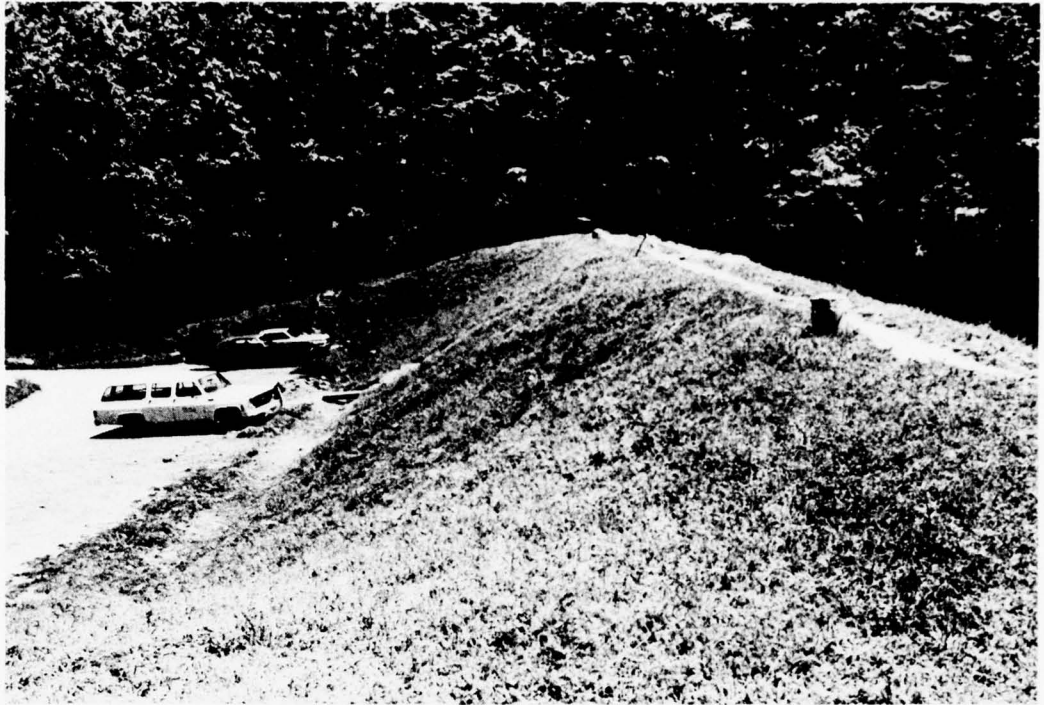
- 3.1.2 Dam: No noticeable seepage was observed in the embankment; however, there is a heavy growth of trees and brush on the downstream face from the parking lot bench area down to the toe.

**PHOTO 1. Downstream Slope of Dam With Parking Area Bench**

- 7.2 Recommended Remedial Measures: It is recommended that the U.S. Forest Service remove the trees and brush from the downstream slope of the dam and reinspect the area. The U.S. Forest Service should also accomplish the following items as part of the annual maintenance program:

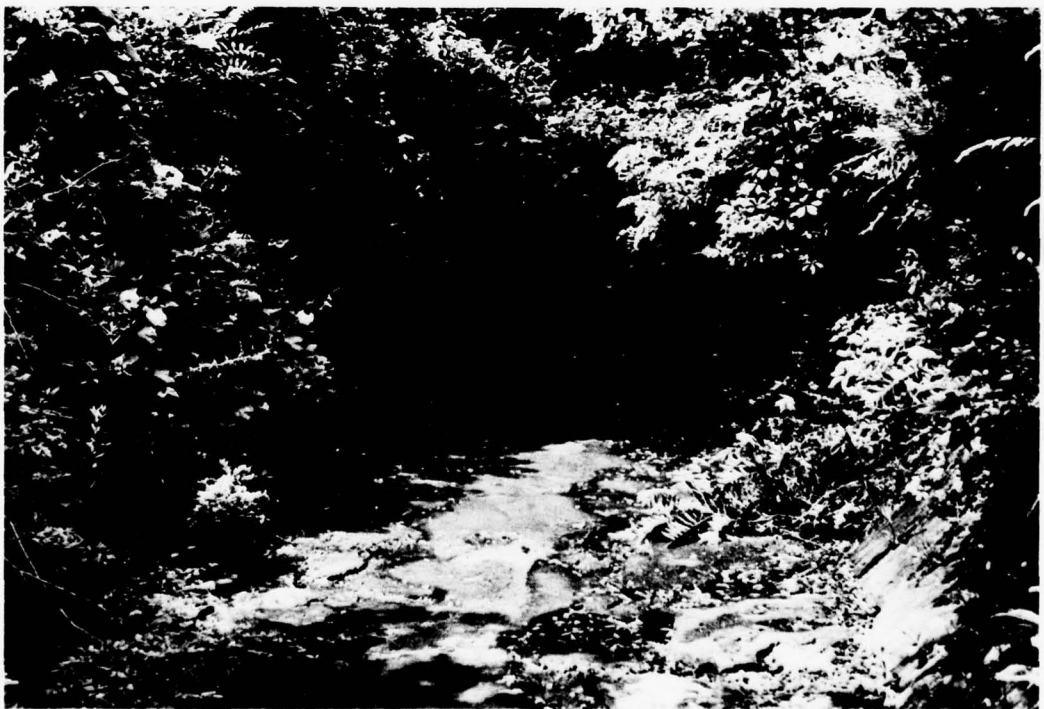
**PHOTO 2. Downstream Drain Outlet Into Masonry Channel  
With Artesian Flow in Small Holes**

- 1) Repair the spalled construction joints in the spillway.
- 2) Annually check the operation of the slide gate on the tower.
- 3) Check seepage in the drain outlet channel monthly and during periods of high reservoir levels for increased flow. Further investigation is also recommended.

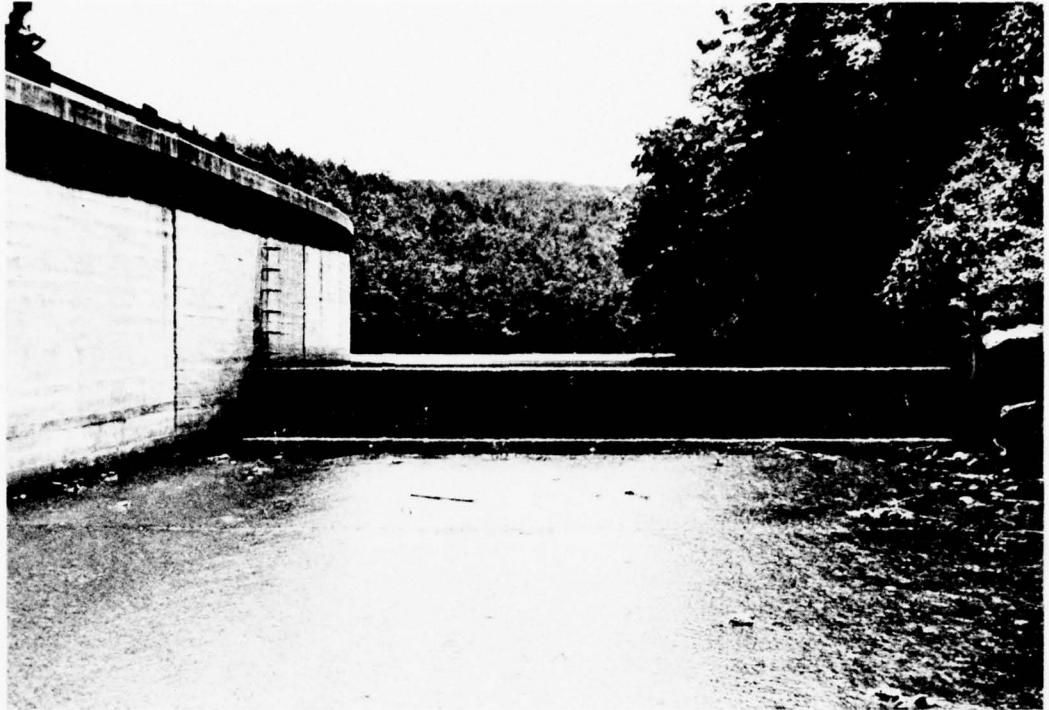
**PHOTO 3. Weir in Principal Spillway With Overflow**

VISUAL EXAMINATION OF	OBSERVATIONS	REMARKS OR RECOMMENDATIONS
CONCRETE WEIR	The concrete weir in the spillway is in good condition with only minor erosion from the overflowing water. The weir has a 3.5 feet crest height and is 1.5 feet thick.	
APPROACH CHANNEL		
DISCHARGE CHANNEL	The discharge channel consists of a concrete slab on the bottom, concrete retaining walls on the right side; and a partial concrete retaining wall with exposed rock for the left side. All the retaining walls and slabs are in good condition, except for spalling at the construction joints of the bottom concrete slab. A six inch clay pipe next to the concrete wall and the hillside on left side was dry. The discharge channel has steep gradients and curved sections for transition at the outlet.	
BRIDGE AND PIERS	There are none.	
LEFT CUT SLOPE	The slope is composed of approximately 30 feet of almost vertically cut very hard quartzite and quartzose sandstone which strikes approximately parallel to spillway with variable 5°-10° dip east into spillway. Seepage and runoff of less than one g.p.m. were observed in several areas. Vertical sets of joints are parallel to spillway. Silty sand and rock fragments (large and small) with some sloughing and traces of clear seeps were exposed on downstream slope. There was scattered growth on the slopes. The rock slopes appear stable with minor amounts of small talus.	The rock slopes appear stable; but intermittent sloughing into the channel may occur on the downstream soil slopes in wet seasons.

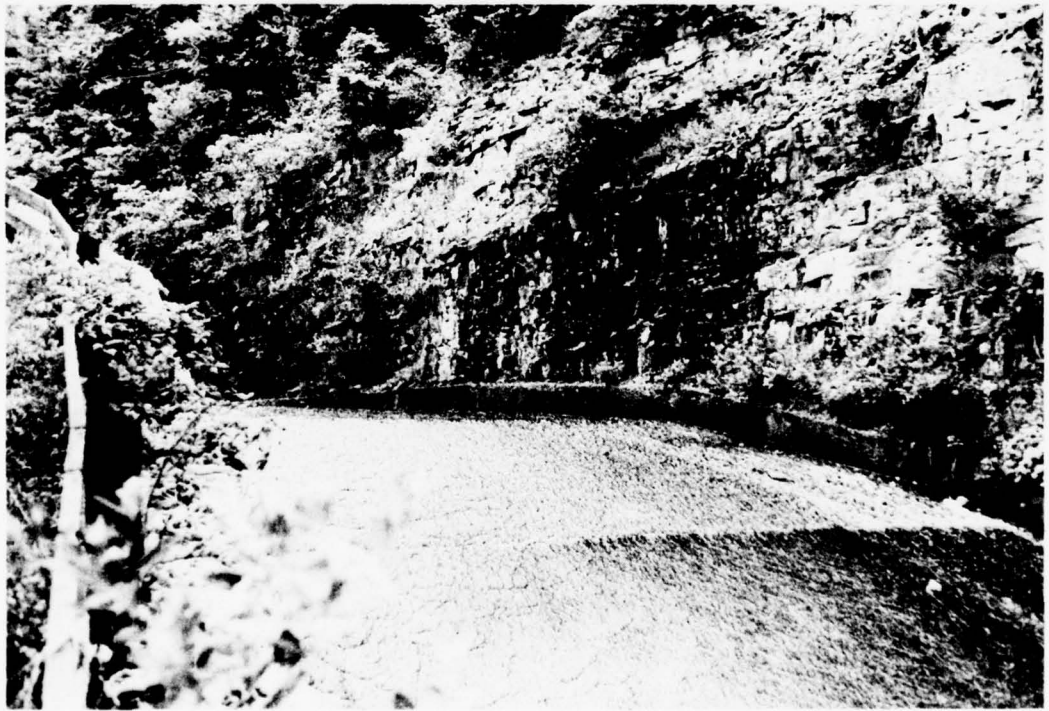
- 3.1.3 Appurtenant Structures: In the principal-emergency spillway, the construction joints in the bottom slab of the spillway are spalled up to three inches wide and three inches deep. Clear seepage was observed in the channel downstream of the outlet pipe. The water was spouting one inch high between the stone joints. The quantity of seepage could not be measured.

**PHOTO 4. Clear Seepage in Rock Cut for Spillway**

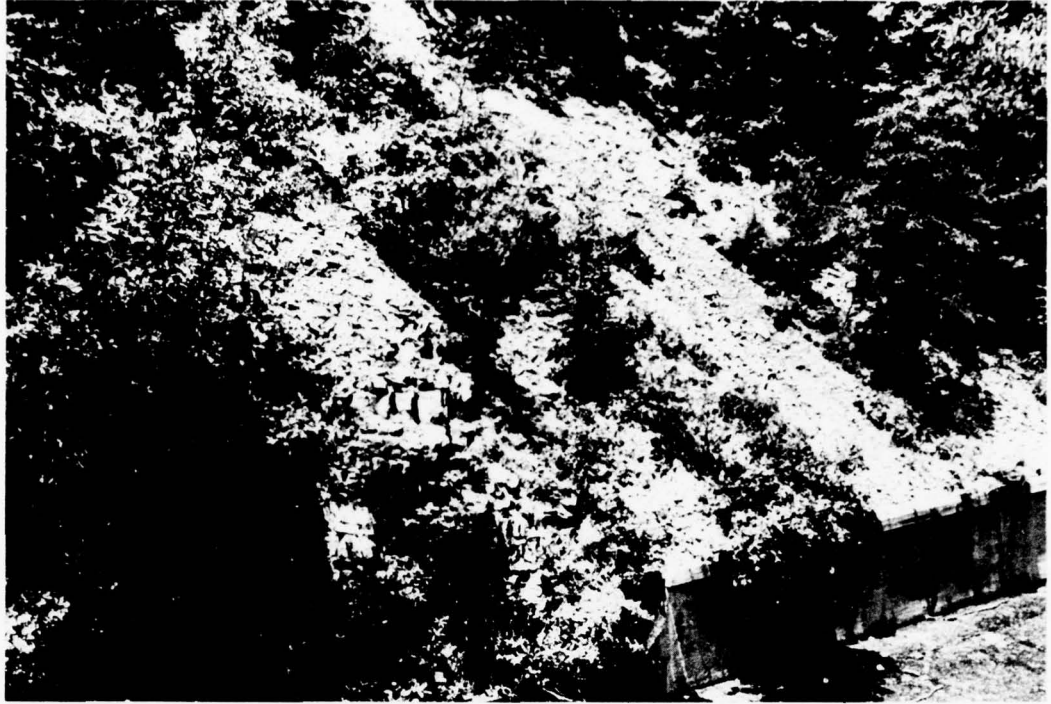
PHOTO 5. Surface Erosion of Slope on Left Bank of Spillway

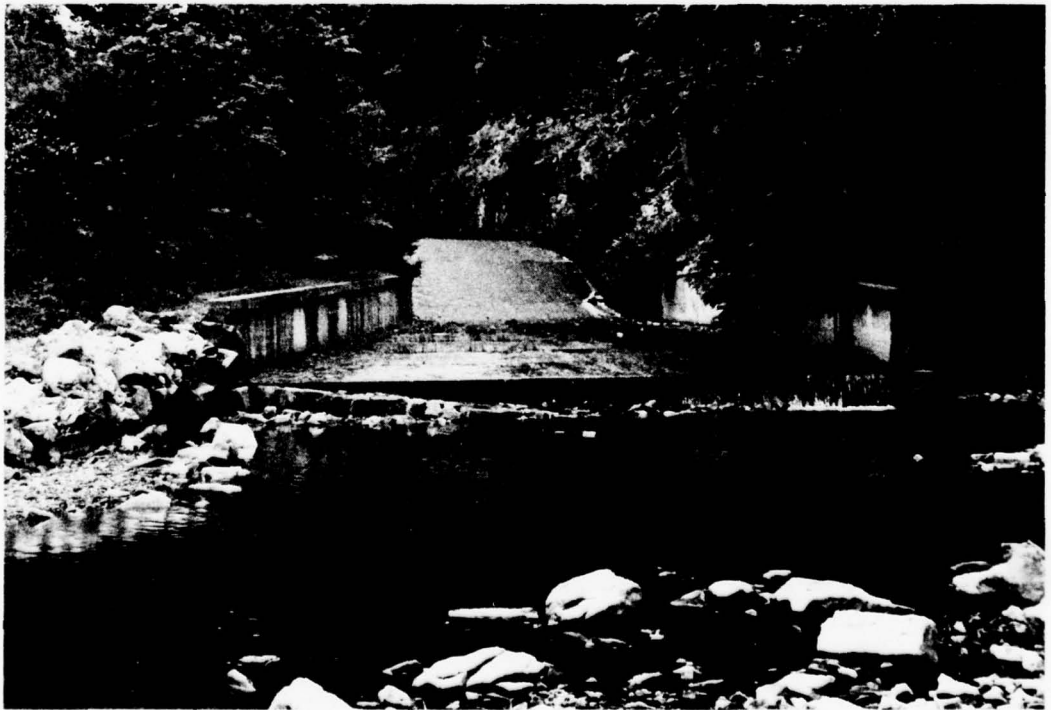
PHOTO 6. Stilling Basin at Outlet of Spillway

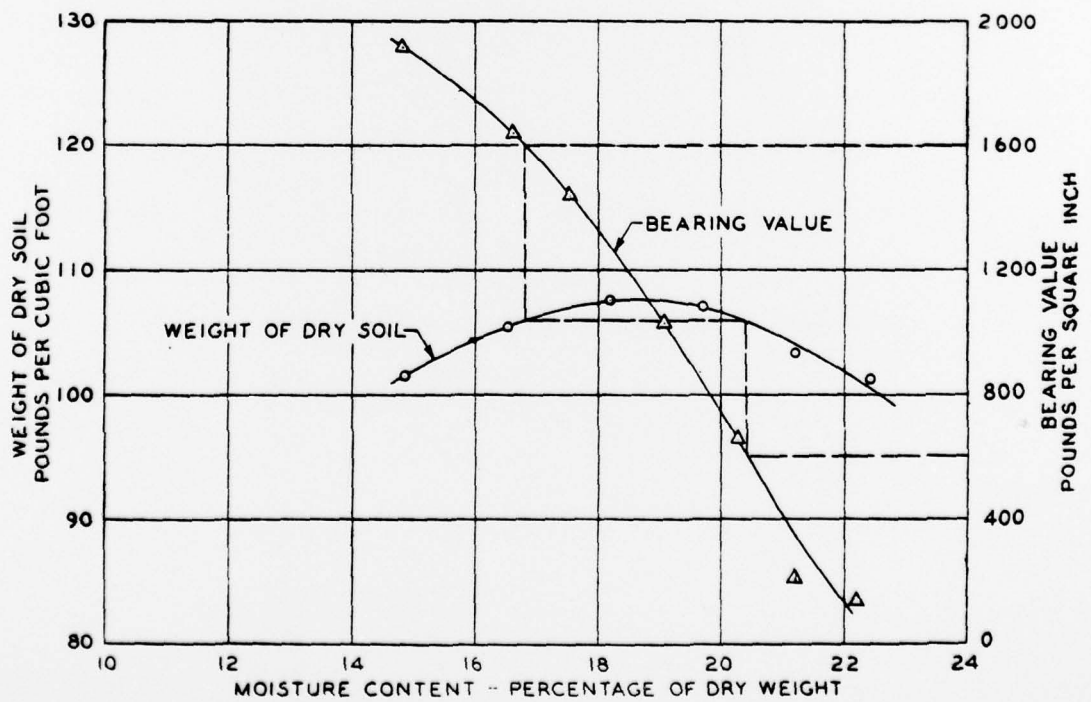
Fig. 2 - Curves obtained from compaction test data

One of the curves resulting from the test, shown in figure 2, serves to illustrate the significance of the compaction data. The weight of dry soil-moisture content curve discloses that for this soil a moisture content of about 19 per cent is required if maximum compaction is to be obtained. The corresponding bearing value is about 1,100 pounds per square inch.

If, at the specified compaction, the bearing value of this particular soil is indicated by the plasticity needle to be higher than 1,100 pounds, the increase can be considered as only temporary if the fill is to be unprotected from water after construction. Thus, a bearing value of 1,600 pounds per square inch indicates a moisture content of slightly less than 17 per cent. This corresponds to a dry weight of about 106 pounds per cubic foot. At this density the soil can take up moisture to a maximum of slightly more than 20 per cent which, in turn, corresponds to a bearing value of but 600 pounds per square inch.
